# Product Bulletin

File: SEB-03-004-2007

Subject: Obsolescence and Replacement  
Policy Statement – Fabricated  
Escalator Steps with Step Body Cracks

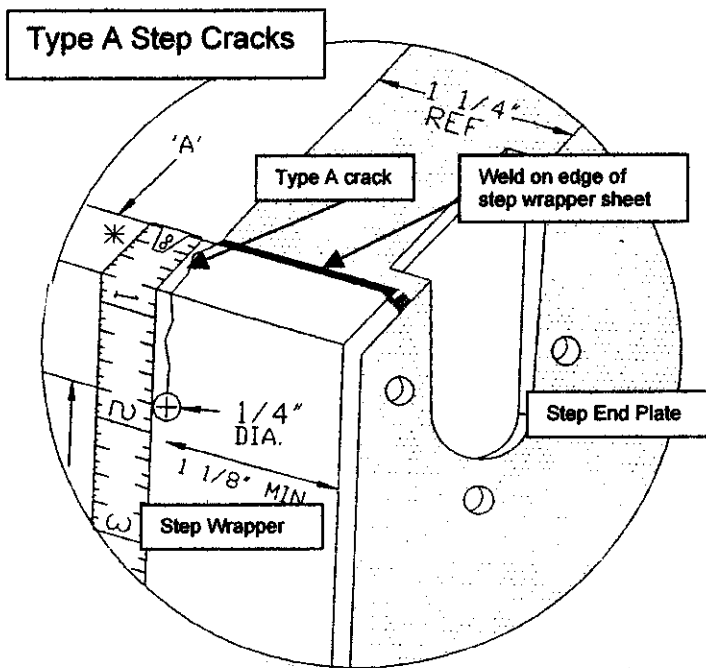
**Type A** – Cracks are located at the lead end of the step (where the chain rollers attach), beginning at the end of the 1" weld on the edge of the step wrapper sheet where it attaches to the end plate. The crack proceeds toward the tread surface at approximately 90 degrees to the weld. (See the diagram below)

Type A cracks are a result of weld stress imparted to the step body during manufacturing. On older style steps, where the step wrapper is welded to the step end plate as shown in the diagram, the step body is quite rigid, and the weld places the wrapper in stress at the end of the weld. In use, the slight twisting that a step is subject to during its travel through the step band path will allow that stress to relieve itself in the form of a crack. The crack is not a result of static loading. Even if a unit is maintained properly, 'A' cracks may develop, and proceed to the point of relief, normally the bend in the wrapper sheet of the step body. However, the crack may progress over the bend in the wrapper sheet, as shown in the diagram, before stopping. *Type A cracks do not necessarily require replacement.* If the crack has not grown beyond 1-3/4" long, as shown in the diagram, measured from point 'A' on the wrapper edge, a relief hole may be drilled at the end of the crack to terminate the cracking.

Steps with Type A cracks do not necessarily require replacement. A 1/4" diameter hole may be drilled at the end of the crack to provide a smooth relief surface at the end of the crack. (See diagram above) This relief hole will terminate further progression of the crack. **NOTE:** If the crack has progressed over the bend in the step body wrapper sheet and has turned toward the side of the step, it should be replaced. The diagram above shows the maximum allowable crack progression for Type A cracks.

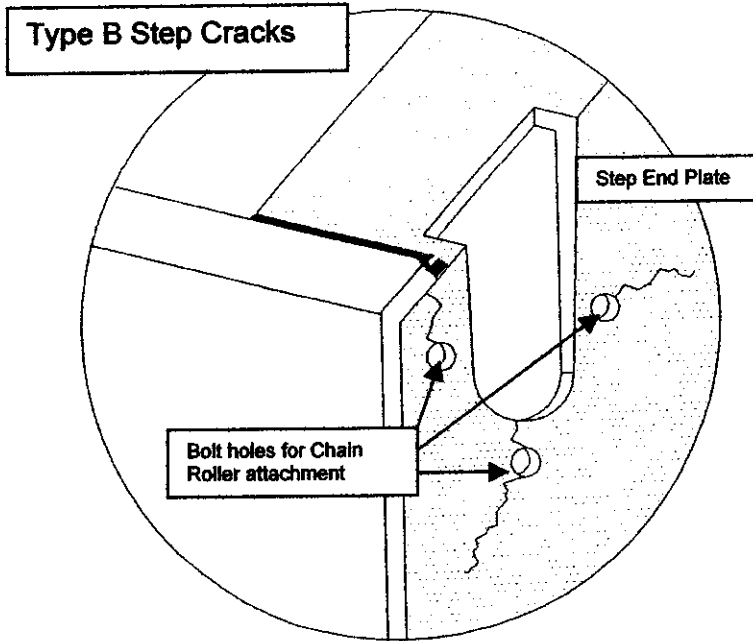
**Type B** – Cracks radiate from the bolt pattern on the end plate where the chain wheel roller flange attaches to the step. (See diagram of Type B cracks for location identification).

Type B cracks are a direct result of fatigue due to cyclic loading over time imposed on the end plate by the chain roller mounting flange attachment. As the steps move over the upper 30 degree transition, the combined weight of any loading on the step wheel is transferred through the chain wheel flange attachment to the side of the step resulting in continued flexing of the step body as it moves around the step band. Novatex board adjustment plays a role in determining the length of time that steps may operate before cracking occurs. Novatex boards must be adjusted properly to support the weight of the chain, steps and live load, and improperly maintained novatex boards can cause higher cyclic loading to occur on the step body, with resultant life reduction. The continued cycling of steps moving around the step band, combined with step end plate loading results in fatigue crack formation at the chain wheel flange attachment point. Type B cracks radiate outward from the mounting holes, as shown. (See Life Cycle section of this bulletin)

**Replacement Policy for steps with Type B cracks**  
**ANY STEPS WITH TYPE "B" CRACKS REQUIRE REPLACEMENT**
