# Product Bulletin

File: SEB-03-004-2007

Subject: Obsolescence and Replacement  
Policy Statement – Fabricated  
Escalator Steps with Step Body Cracks

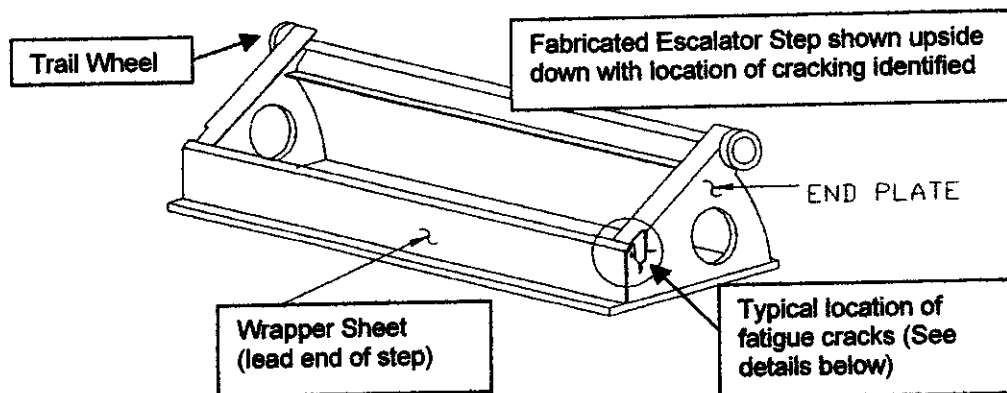
During the lifetime of escalator step band components it has been found that on fabricated steps used on HR type escalators, where the chain rollers are individually flange mounted to the step body end plate, cracking can occur in the sheet metal body, due to long term cyclic loading fatigue. The length of time required to develop these cracks is dependent on the equipment operating hours, unit operating speed, loading on the equipment, environmental and building conditions, and service care provided. Therefore regular maintenance inspections are necessary to determine if cracks have developed, and to determine if steps should be replaced.
